HYDRODYNAMICS OF DOWNSTREAM POINTED GUIDEVANES

HESS CREEK MEANDER BEND REALIGNMENT

A
THESIS

Presented to the Faculty
of the University of Alaska Fairbanks

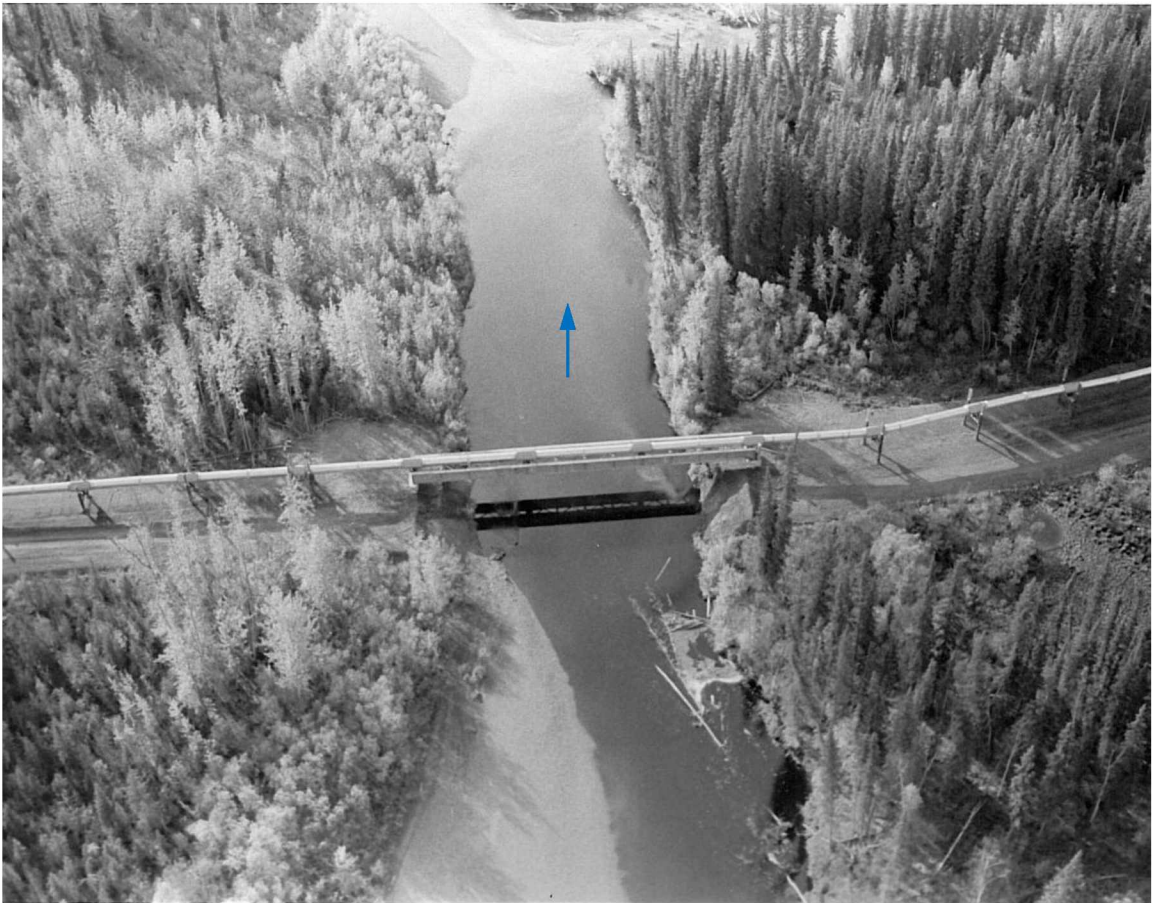
Figure 2.1 Photograph of Pipeline bridge crossing in 1977 shortly after installation

The Trans-Alaska Pipeline Bridge crosses Hess Creek (Latitude 69.968611 north, Longitude 148.715833 west) at pipeline milepost 375 on its 1285 km journey from the Beaufort Sea at Deadhorse, Alaska to the port of Valdez. At the time of construction in 1976, the pipeline crossing was a stable reach with well-vegetated banks and few signs of bank erosion (Fig. 2.1).

At the pipeline crossing the creek has a torturous meander pattern with numerous oxbows on reaches upstream and downstream of the bridge. In a span of four decades from pipeline route selections in the 1960's or earlier to 1980's two meanders were cut-off. One located upstream and another downstream of the bridge that was installed in 1977. These cut-offs altered the stream gradient in the vicinity of the crossing resulting in increased bank erosion. The first cutoff was fully developed in the early 1970's (HDR Engineering 1992). It was 625 m upstream of the bridge and reduced the meander length from 1825 m to 300 m. Cause of the cutoff is not known but may be due to lateral stream migration in ice rich soils and not precipitated by a major flood. The second cutoff was 375 m downstream of the pipeline bridge that became fully developed by the 1980's. The meander length was reduced from 470 m to 335 m likely due to a series of high flood events from 1975 to 1978. In ice rich soils hydraulic and thermal erosion is accelerated whenever the soils are exposed, a process of lateral stream migration in permafrost environments that is well documented (e.g. Brown and Kreig 1983). Therefore from planning, design and installation of the bridge crossing the reach most likely was already in a state of disequilibrium however subtle the signs may have been (Fig. 2.1).

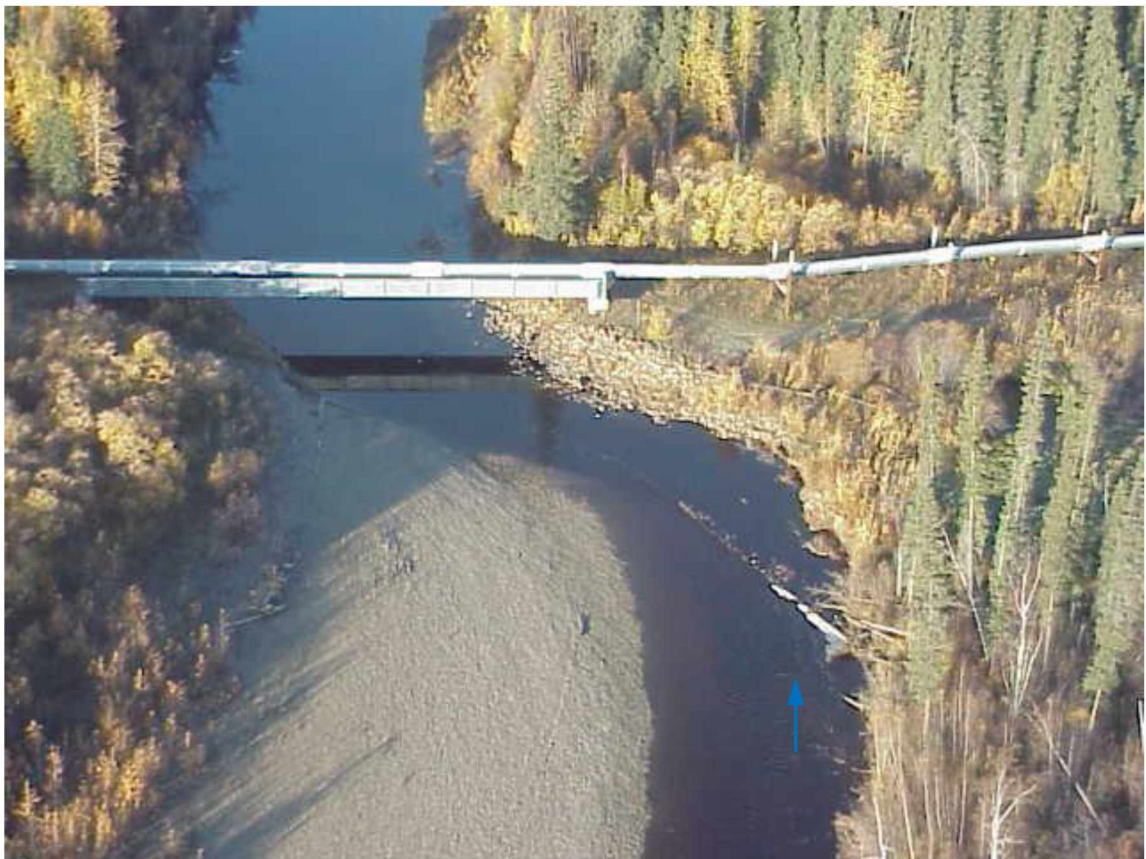
Figure 2.2 Photograph of Hess Creek, 2001 lateral bank migration

Two decades later, considerable bank erosion upstream of the pipeline bridge was observed. Continued lateral movement due to erosion resulted in formation of a meander bend upstream of the bridge in what used to be a relatively straight reach at the time of

construction. This resulted in a bridge misalignment between its upstream and downstream reaches. There was a risk that in a flood event the stream could outflank the bridge abutment (Fig. 2.2).
